## **BAUER INSPECTION & CONSULTING SERVICES**

## Maintenance Reminder Newsletter

1. Double Lugging.
2. Exterior Painting
3. Siding Repair

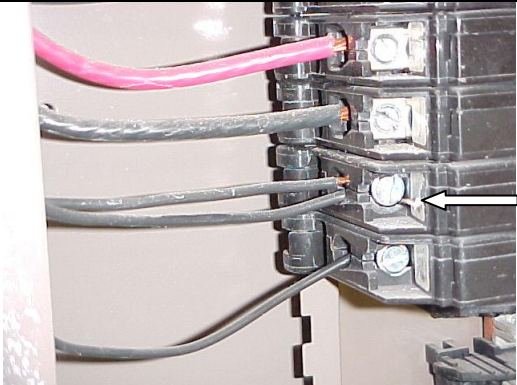
| <p>Double lugging</p> | |

“Double lugging” is a common electrical defect. “Double Lugging” is the connection of two circuit wires to one breaker in the Main Electrical Panel. The reason this is unsafe is because when two wires are secured under one screw, one of the wires might be loose. Often, I find a 12 ga. wire and a 14 ga. wire double lugged to a single breaker. The screw might tighten down on the 12 ga. (larger) wire, but not the smaller 14 ga. Wire.

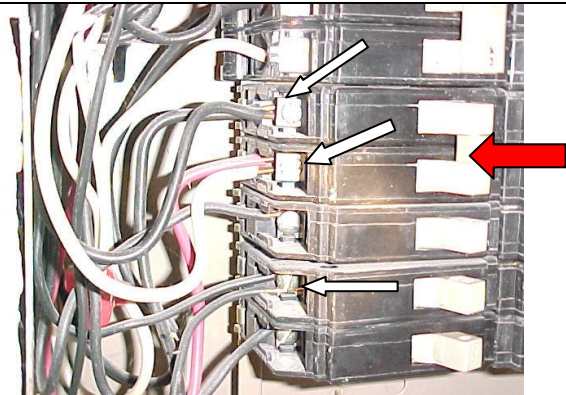
| <p>220 v breaker double lugged and a 110v breaker double lugged.</p> | |

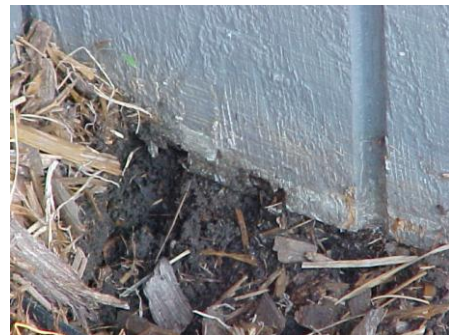
Typical damage to plywood siding from soil-to-wood contact.

The same or worse damage can occur on the composition siding used in most new houses today.

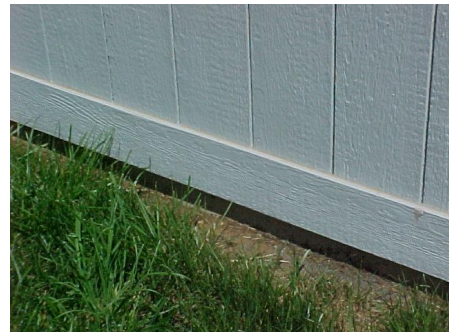
Bottom edge of siding that has been repaired with a piece of trim.

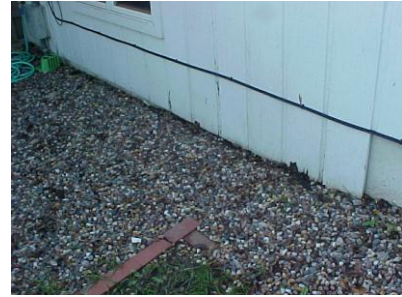
Soil to wood contact has caused damage to bottom of Siding.

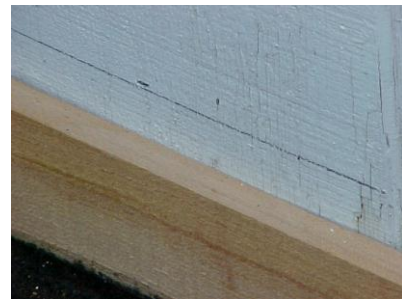
Set a Guide 1 1/2" below the mark to guide the circular saw.

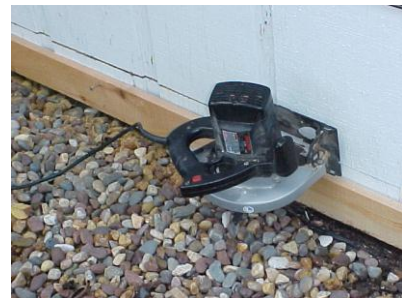
Set the circular saw to cut a depth of 1/2" (the thickness of the siding panels) and cut the length of the siding.

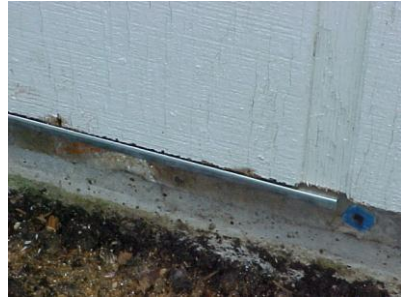
Remove the damaged bottom edge of the siding and install the Z-bar flashing. It will slide up between the siding and the sheathing. It does not need to be secured.

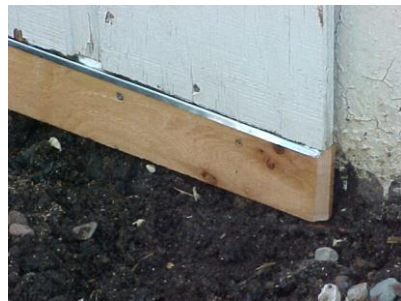
Install the trim board with deck screws into the sill plate and caulk and paint as required.

When using cedar, it is best to prime ALL sides of the cedar with an oil based primer before installing.

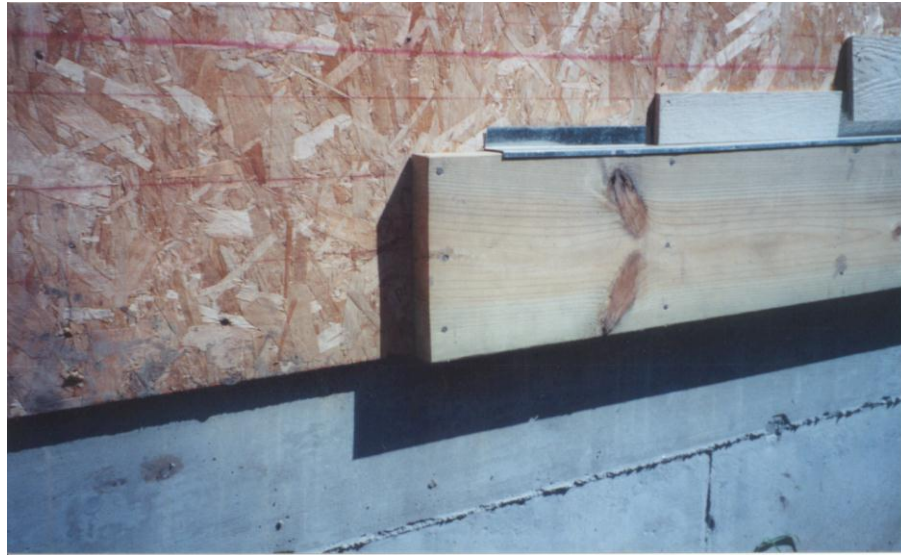
This photo shows new construction with a pressure treated board on the bottom, the Z flashing behind the composition siding and over the pressure treated “trim” board.

This method will work to repair both the lap siding and the 4 x 8 sheet paneling siding, when the bottom edge is damaged.
